PRESERVATION BRIEFS

11

Rehabilitating Historic Storefronts

H. Ward Jandl

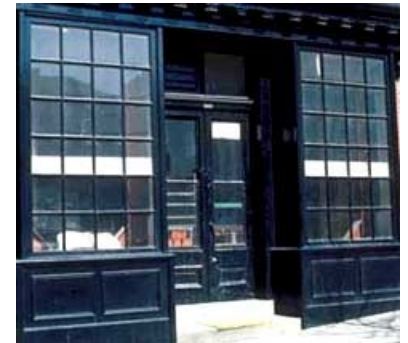
This cast iron storefront from the late 19th century has been well maintained over the years. Photo: NPS files.

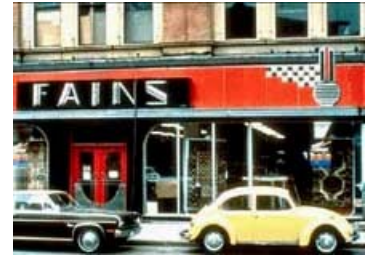
This 1930s Moderne storefront has gained significance over time and should be preserved. Photo: NPS files.

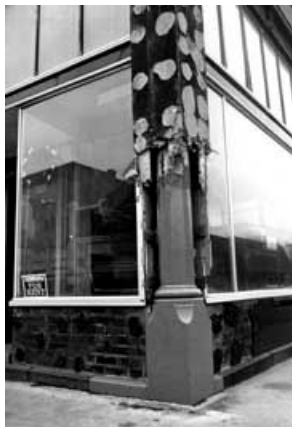
Storefronts of the 1940s, 50s, and 60s were frequently installed by attaching studs or a metal grid over an early front and applying new covering materials. Photo:

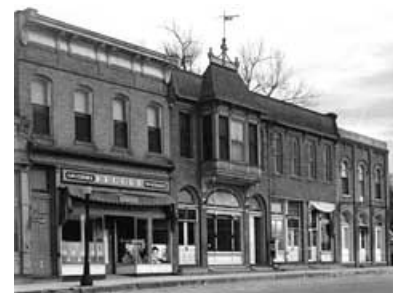
By evaluating the components of a storefront as well as their existing condition, a successful rehabilitation is more likely. Photo: HABS collection, NPS.

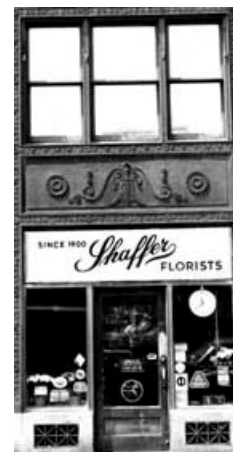
This finely detailed bronze storefront is typical of many constructed during the 1920s. The original grilles, spandrel panel and windows are all intact. Photo: NPS files.

Bronze storefronts, common to large commercial office buildings and major department stores of the 20th century, can be cleaned by a variety of methods; since all cleaning removes some surface metal and patina, it should be undertaken only with good reason (such as the need to remove encrusted salts, bird droppings or dirt). Excessive cleaning can remove the texture and finish of the metal. Since this patina can protect the bronze from further corrosion, it should be retained if possible. If it is desirable to remove the patina to restore the original surface of the bronze, several cleaning methods can be used: chemical compounds including rottenstone and oil, whiting and ammonia, or precipitated chalk and ammonia, can be rubbed onto bronze surfaces with a soft, clean cloth with little or no damage. A number of commercial cleaning companies successfully use a combination of 5% oxalic acid solution together with finely ground India pumice powder. Fine glass-bead blasting (or peening) and crushed walnut shell blasting also can be acceptable mechanical methods if carried out in controlled circumstances under low (80-100 psi) pressure. Care should be taken to protect any adjacent wood or masonry from the blasting.

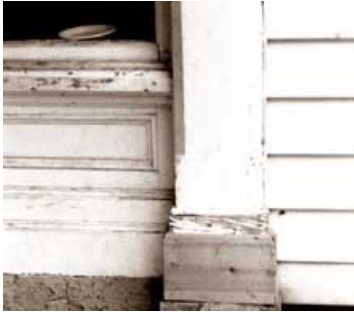
Rather than replace an entire wooden storefront, a new wooden component can be pieced-in, as seen in this column base. Photo: NPS files.

Where components of wood storefronts are so badly deteriorated that they cannot be stabilized, it is possible to replace the deteriorated parts with new pieces. These techniques all require skill and some expense, but are recommended in cases where decorative elements, such as brackets or pilasters, are involved. In some cases, missing edges can be filled and rebuilt using wood putty or epoxy compounds. When the epoxy cures, it can be sanded smooth and painted to achieve a durable and waterproof repair.
